**Wetland delineation by Critical Areas Consulting, 2013**

**Wetland Delineation**

City of Long Beach

Tax Lots  
10111634649  
and portions of  
10111631054

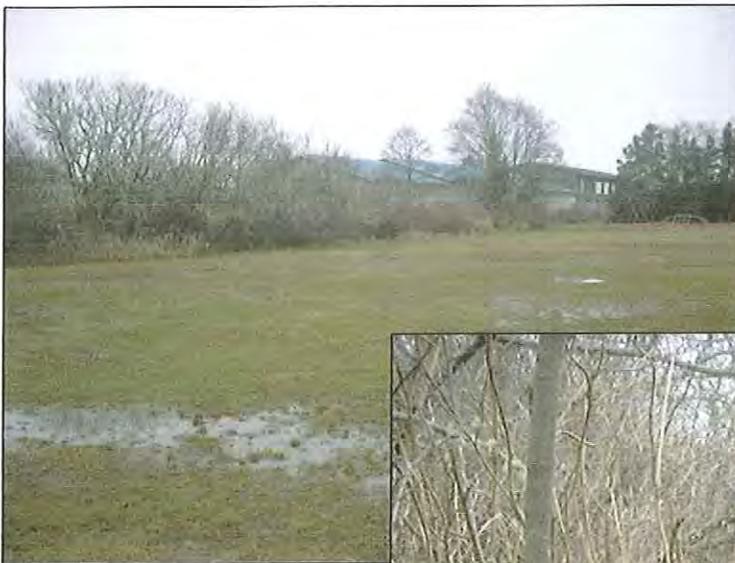
Site Photograph 1 (left): View to the southeast showing the ballfield, Note standing water in the foreground. The baseball diamond is located in the far south corner of the field, seen on the right-hand side in the photograph.

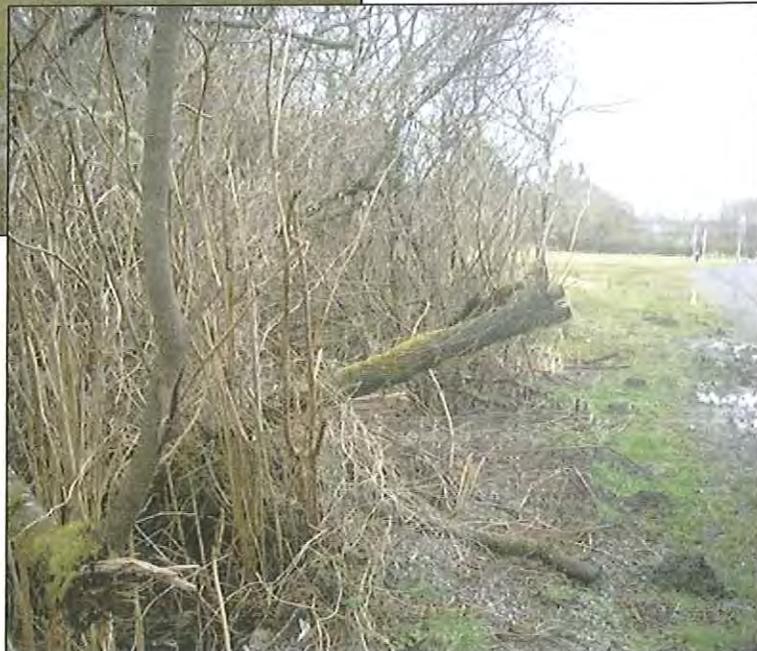
Site Photograph No. 2 (right): View to the south of the northern scrub-shrub portion of the wetland. The driveway and parking area for the elementary school is not seen but is located immediately right of the image.

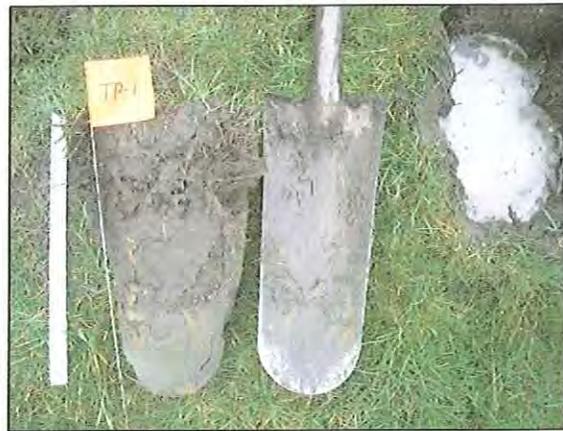
Photograph No. 3: Photograph taken from above of TP-1 located in the Category IV wetland identified in this report. Soil texture is about 5 inches of silty sand overlying gray sand. Note ground water in test pit at about 3 inches below surface grade.

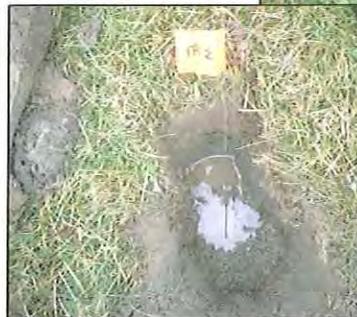
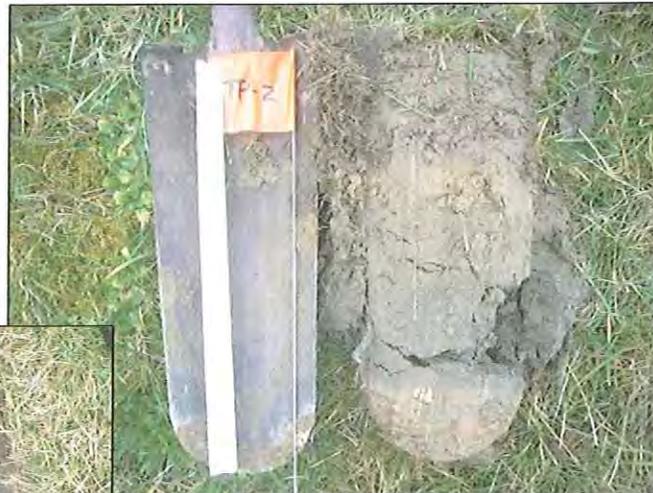
Photograph No. 4a (right) and 4b (below): Views from above of TP-2 soil and test pit located in the Category IV wetland near the baseball diamond identified in this report. Soil texture is about 5 inches of sandy silt overlying gray sand. Note ground water in test pit at about 12 inches below surface grade.

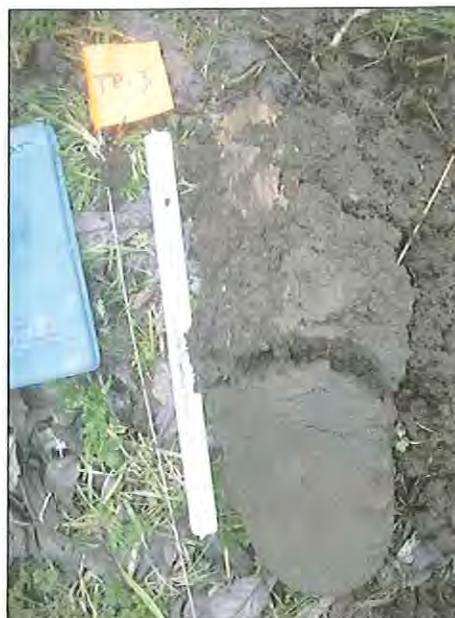
Photograph No. 5: Photograph taken from above of TP-3 soil located in the Category III scrub-shrub wetland identified in this report. Soil texture is about 7 inches of sandy silt overlying silty sand. Groundwater (not shown) stabilized at about 8 inches below grade.

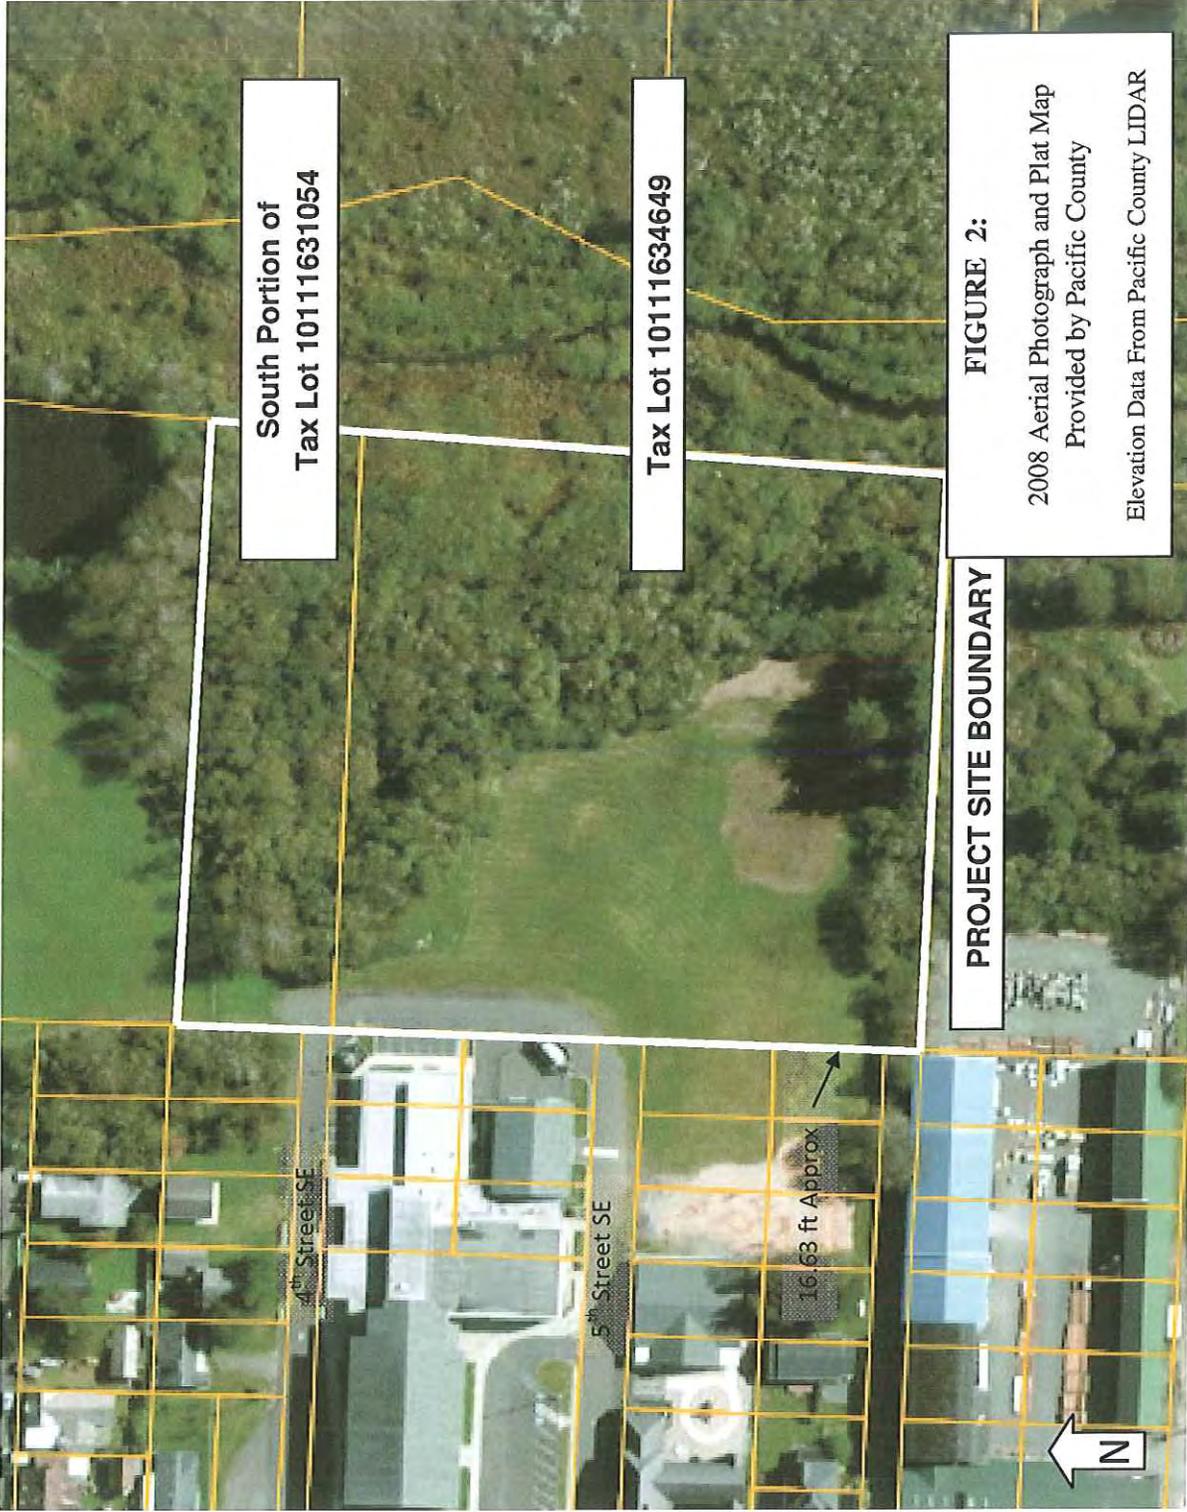
**FIGURE 2:**  
2008 Aerial Photograph and Plat Map  
Provided by Pacific County  
Elevation Data From Pacific County LIDAR

The project site (including the southern extent of the northern parcel) is roughly rectangular in shape and is accessed by 4<sup>th</sup> or 5<sup>th</sup> Streets SE which extend east from Washington Avenue S., Oregon Avenue S., and Pacific Avenue (State Hwy 103) to the West. Site topography is relatively flat at an elevation of approximately 16 ft msl (data from USGS LIDAR and Pacific County, see Figure 2) sloping gently upwards from east to west with an abrupt 1 to 2 ft rise where it meets the parking lot and access drive for the elementary school. The majority of the project site has been utilized as a ball field and is regularly mowed with a portion of the inner ball field slightly elevated above the surrounding field. The ballfield occupies the majority of the western half of the project site with scrub-shrub vegetation occupying the majority of the Eastern and Northern project site (see Figure 2).

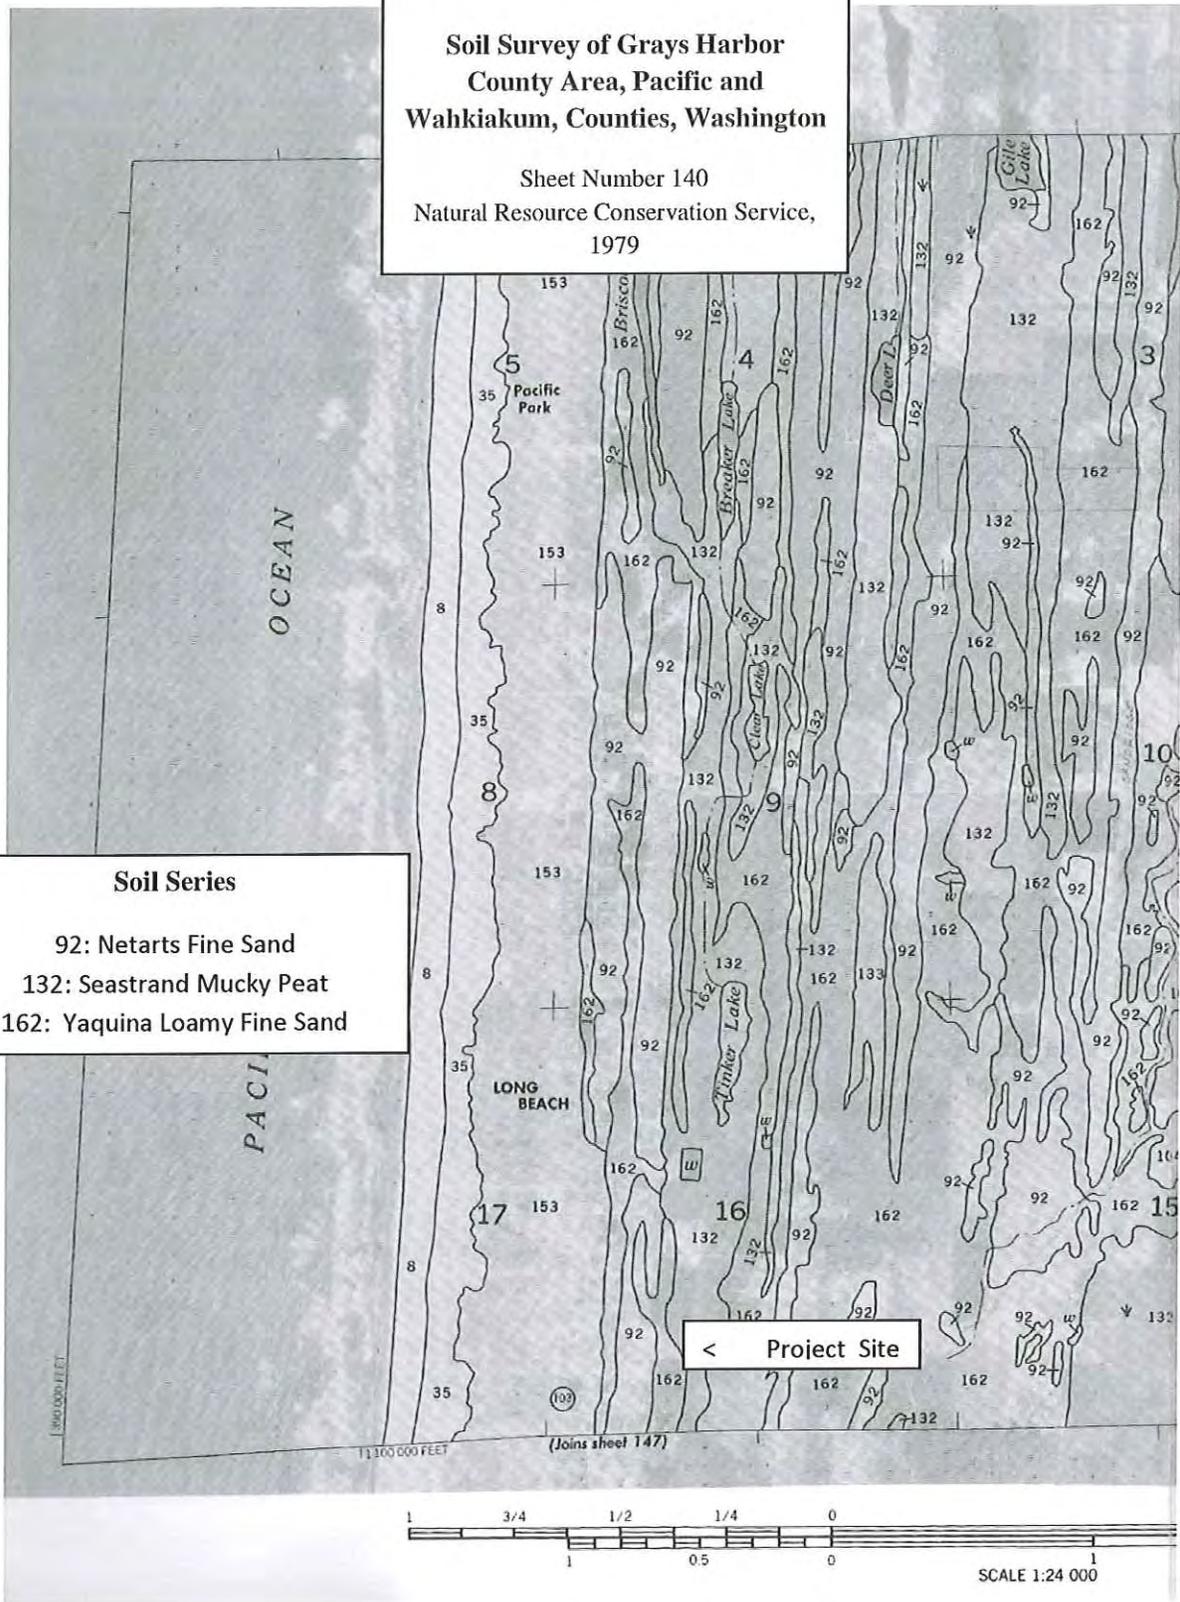
**FIGURE 3**  
**Soil Survey of Grays Harbor**  
**County Area, Pacific and**  
**Wahkiakum, Counties, Washington**  
 Sheet Number 140  
 Natural Resource Conservation Service,  
 1979

The Soil Survey of the Grays Harbor County Area, and Pacific and Wahkiakum Counties, Washington (Soil Survey) indicates that the project site area supports Netarts Fine Sand (series no. 92), Seastrand Mucky Peat (series no. 132) and Yaquina Loamy Fine Sand (no. 162) (see Figure 3, Pacific County NRCS Soils Map) In the project site area the soil map shows a narrow finger of Yaquina loamy fine Sand separating Netarts fine Sand to the west and Seastrand mucky peat to the east. According to the Soil Survey, these soil series are very deep soils classified as well-drained with moderately

**Soil Series**  
 92: Netarts Fine Sand  
 132: Seastrand Mucky Peat  
 162: Yaquina Loamy Fine Sand

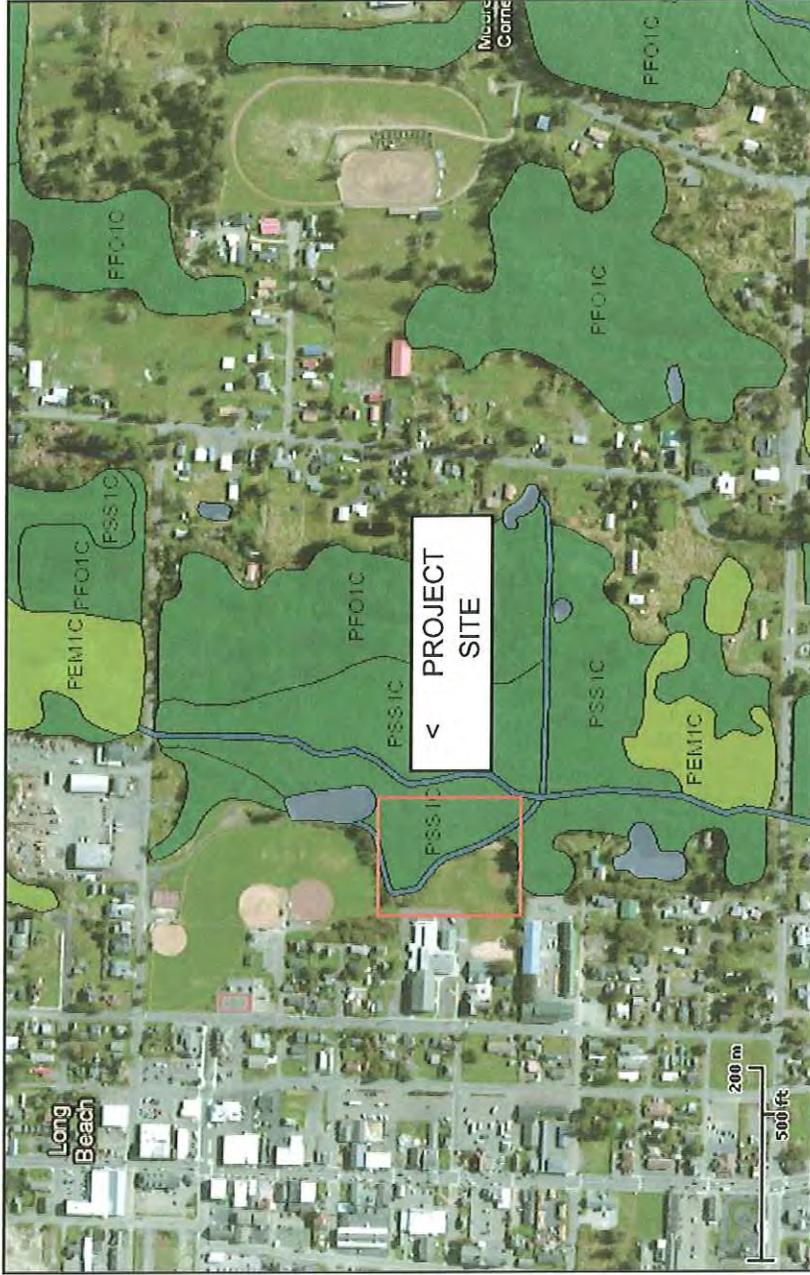
Figure 4 NWI Map

The National Wetlands Inventory (NWI) map did not show wetlands on the baseball field portion of the project site. The wetlands inventory map shows wetlands associated with the natural scrub-shrub vegetation, labeled as PSS1C or Palustrine Scrub-shrub, with vegetation including broad leaved deciduous (1), and seasonally flooded (C). Local wetlands maps were not available for this investigation.

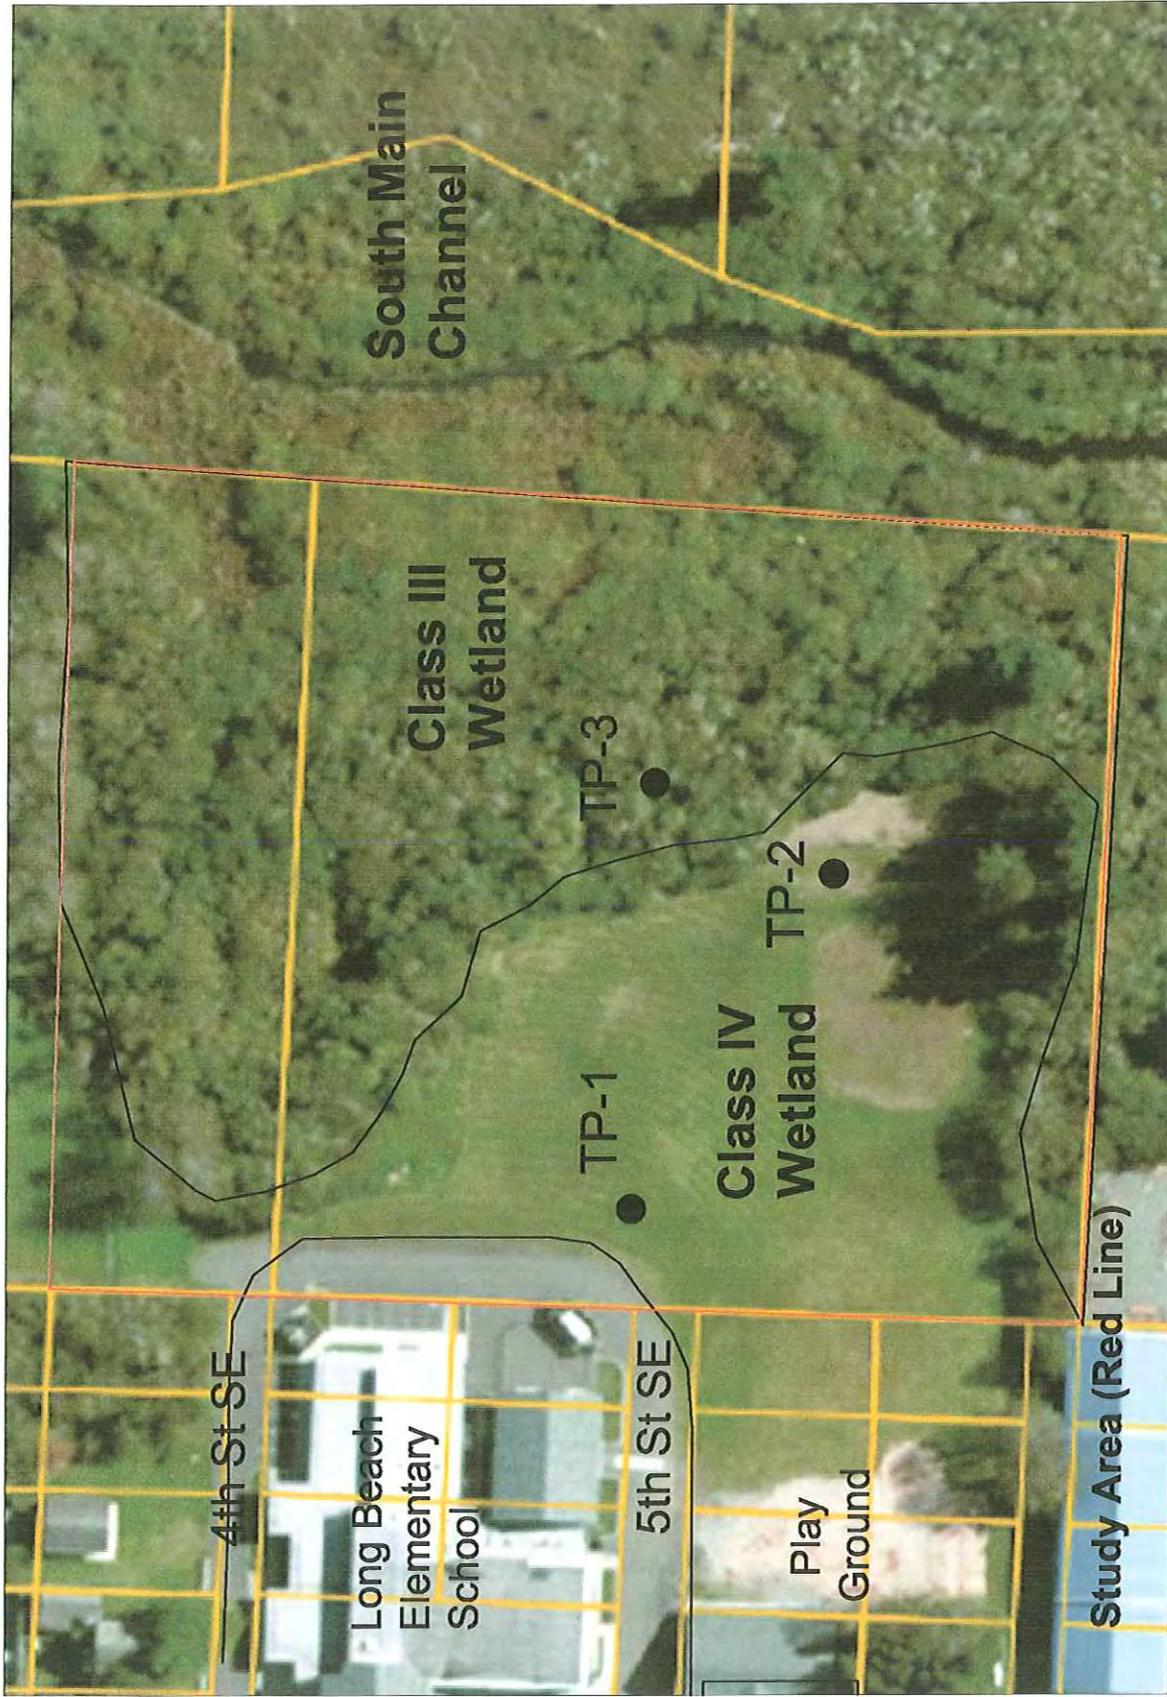
**FIGURE 5 WETLAND DELINEATION SITE PLAN**

For this investigation, a total of three surveys were conducted on the subject parcel including one survey near the west edge of the mowed field, one survey near first base of the baseball diamond and one survey in the scrub-shrub wetland near the baseball diamond. The identified wetlands at the site are limited on the west by the playground and driveway. On the north the scrub-shrub wetlands (see Photograph 2) transition abruptly to an area dominated by invasive grasses (*P. arundinacea*) and further north and offsite to another mown baseball field (see Figure 4). Vegetation surveys were labeled TP-1 (Test Pit number 1) through TP-3. (See Figure 5 for test pit locations.)
